## **POSTER SESSION PARTICIPANTS**

### **CASE STUDIES OF MITIGATION OF FOD, FRETTING FATIGUE, CORROSION FATIGUE AND SCC DAMAGE BY LOW PLASTICITY BURNISHING IN AIRCRAFT STRUCTURAL ALLOYS**

### **COMPOSITE PATCH DESIGN STUDY FOR EXTENSIVELY CORRODED WING PANELS LOADED IN COMPRESSION**

2005 USAF Aircraft Structural Integrity Program (ASIP) Conference  
29 November - 01 December 2005  
The Peabody Memphis ~ Memphis, Tennessee

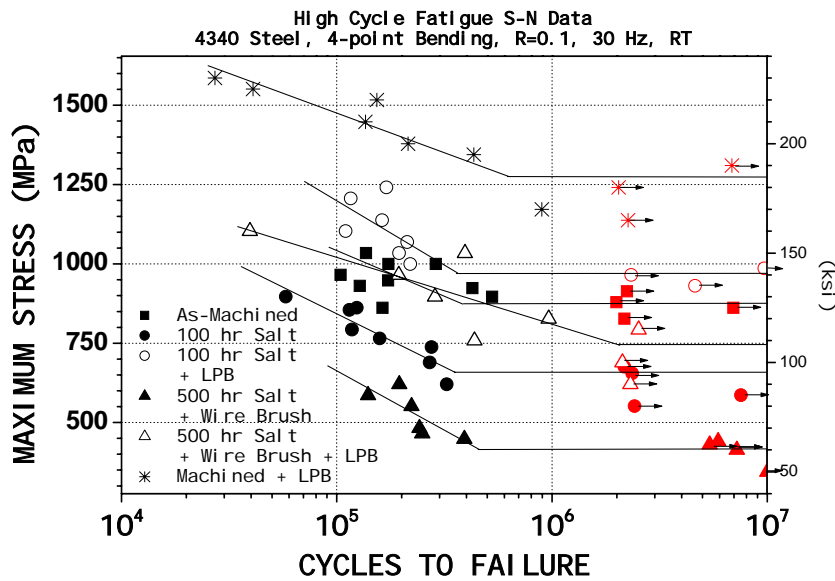
Figure 3 – HCF S-N plots of salt-fog exposed 4340 steel

Figures 3 and 4 show the fatigue performance in the as-machined and LPB treated conditions before and after salt-fog exposure to 100 and 500 hours. It is evident from these figures that prior corrosion damage leads to a substantial debit in fatigue performance. LPB treatment results indicate significantly better fatigue performance than the as-machined condition. Also, both the S-N data and the bar chart indicate effective mitigation of damage from salt-fog exposure in LPB treated material.

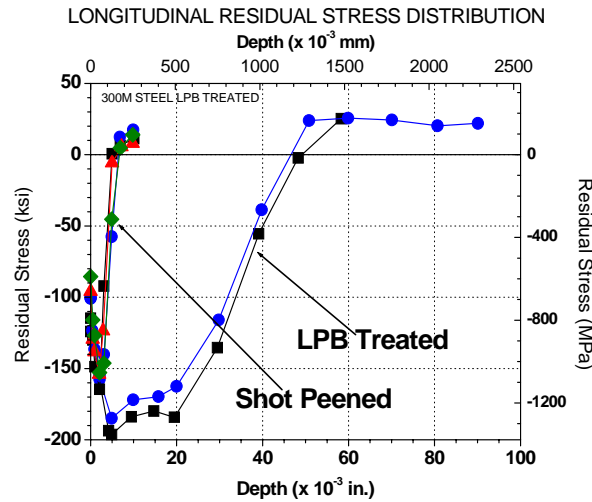
Figure 6 – Residual stress profiles of shot peened and LPB treated 300M HSLA steel specimens before and after 48 hours of thermal exposure to 400F

A comparison of residual stress profiles from shot-peened and LPB treated 300M HSLA steel specimens are shown in Figure 6. LPB treated specimens show compression to a depth of over 0.04 in. (1.2 mm) while the SP resulted in only 0.005 in. (0.1 mm) deep compression. In both cases, thermal exposure to 400°F for 48 hours did not result in significant stress relaxation. A bar chart comparing the fatigue strengths of baseline material in the presence of a 0.01 in. (0.25 mm) deep FOD and/or active salt corrosion, with similar test conditions for shot peened and LPB treated specimens are shown in Figure 7. The results indicate both active salt corrosion and FOD decrease the fatigue strengths by a factor of 5, while the combined effects of FOD and active corrosion are even worse. SP has marginal beneficial effects when only active corrosion is considered, while no benefit is seen with the presence of FOD or with the combined presence of FOD and active corrosion. The results also indicate Ni-Cr plating had no benefit in mitigating corrosion fatigue damage. As seen in the LPB treated samples, almost all the damage from active salt corrosion, FOD, and the combined damage conditions are fully mitigated. The Ni-Cr plating on top of the LPB treated surface performed better than the shot-peened surface. Fractography indicated that all corrosion fatigue cracking damage initiated from corrosion pits. LPB did not stop the formation of corrosion pits, rather the crack initiation and growth processes were completely blocked by the deep compressive residual stresses. The Ni-Cr plating was

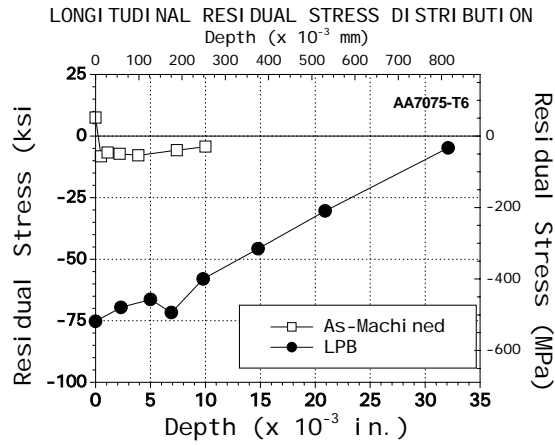
Figure 9 – Residual stress distribution in AA7075-T6 in the as-machined and LPB conditions

The residual stress profiles of AA7075-T6 fatigue specimens in the as-machined and LPB treated condition are shown in Figure 9. A depth of compression of nearly 0.035 in. (0.9 mm) was achieved with LPB treatment. Figure 10 shows the HCF data for AA7075-T6 specimens tested in the as-machined and LPB treated conditions in both active corrosion mode as well as with prior salt-fog exposure. In the as-machined condition both active corrosion and prior salt-fog exposure results in a significant drop in the fatigue performance in that the fatigue strength at  $10^7$  cycles drop by 50% from about 32 ksi to 16 ksi. With LPB treatment the HCF properties are 50% higher than the as-machined condition. The results indicate the compressive residual stresses from LPB not only mitigated the corrosion pitting damage, but also far exceed the baseline performance.

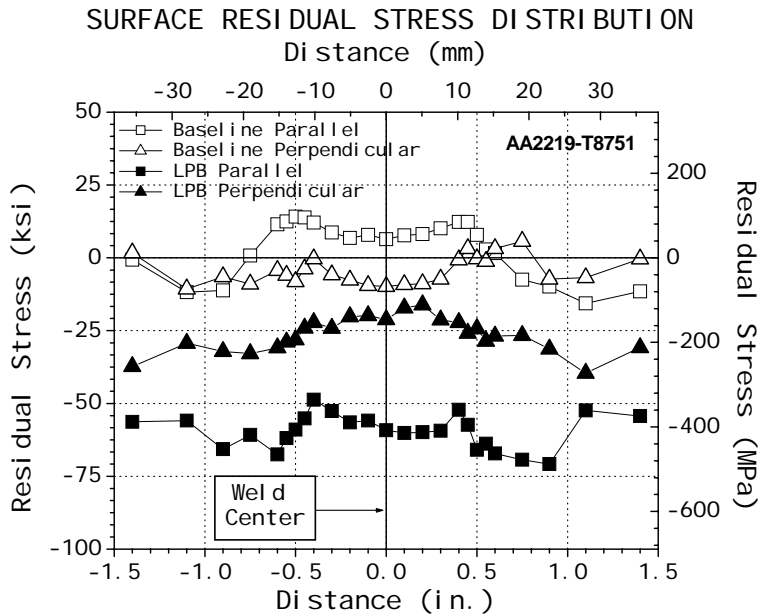
Figure 11 - Surface residual stress distribution in FSW plate AA2219-T8751

The residual stress distributions parallel and perpendicular to the weld on the surface of a friction stir welded plate of AA2219-T8751 are shown in Figure 11 for the as-welded condition and after LPB processing. As indicated in Figure 11, the surface tensile residual stresses created by the FSW process are completely eliminated and in place a compressive residual stress state is introduced by LPB treatment.

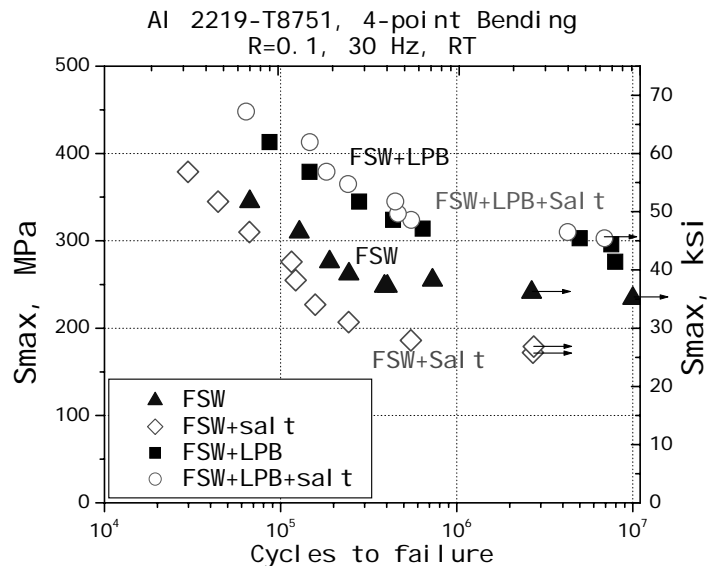
Figure 12 - HCF S-N plots for AA2219-T8751

A comparison of baseline FSW versus LPB treated FSW with and without active corrosion is shown in Figure 12. The fatigue strength of baseline FSW AA2219-T8751 is shown to decrease from nominally 35 ksi to 25 ksi in the presence of active corrosion. LPB treated FSW both in the baseline condition and the active corrosion conditions performed equally well and surpassed the performance of the baseline FSW. Improvement in the fatigue performance is evident at

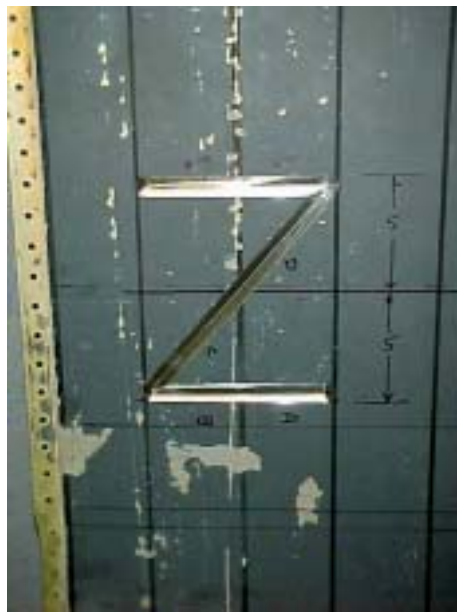
Figure 2. Centrally-located Milled “Z” damage.

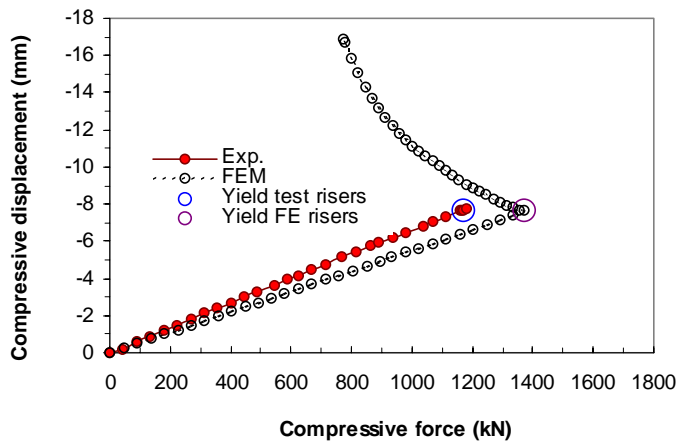
Figure 7. Displacement versus force (pristine panel).

Analysis results show good agreement between the model and the test for the pristine panel case. The displacement-force relationship observed in the test and in the simulation is shown in Figure 7.

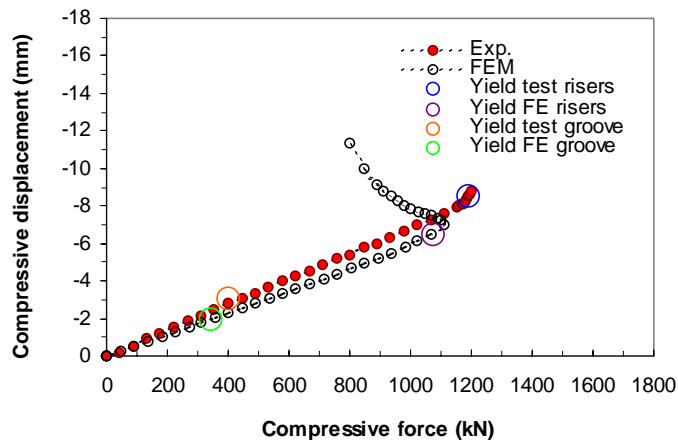
Figure 8. Displacement versus force (damaged panel).

The damaged panel simulation also captured the overall phenomena that occurred in the test. However, the model predicted, as intuition would suggest, a failure load lower than that observed in the pristine case. The displacement-force relationship for this case is shown in Figure 8.

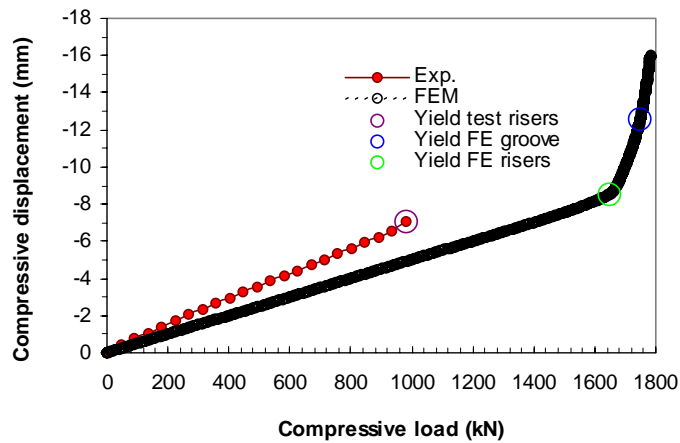
Figure 9. Displacement versus force (repaired panel).

However, the FE model did not reproduce all aspects of the tested repaired panel behavior. As for the damaged case, and contrary to what was observed in the test, the model predicted the expected behavior, that is the patch would restore the panel compressive strength, as planned by the patch designer using CRAS. The displacement-load relationship for the repaired panel is shown in Figure 9.

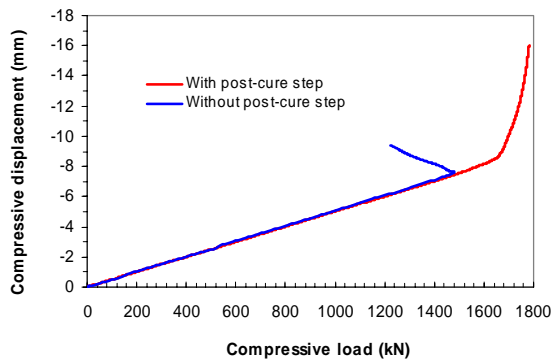
Figure 10. Effects of cure step on force-displacement relationship.

To evaluate the effects of the post-cure residual strains, the repaired panel test was simulated without the post-cure step and compared to the analysis including the thermal effects. Some of the key characteristics of the two simulations are compared in Figures 10 and 11.

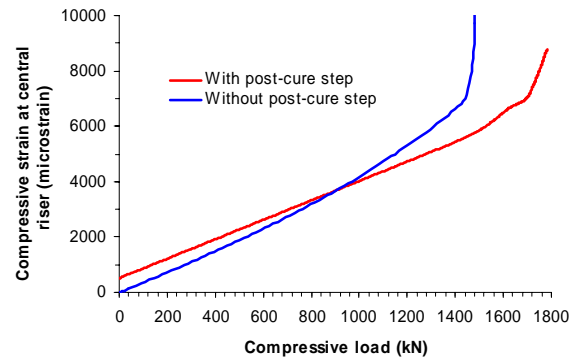
Figure 11. Effects of cure step on central riser strain.

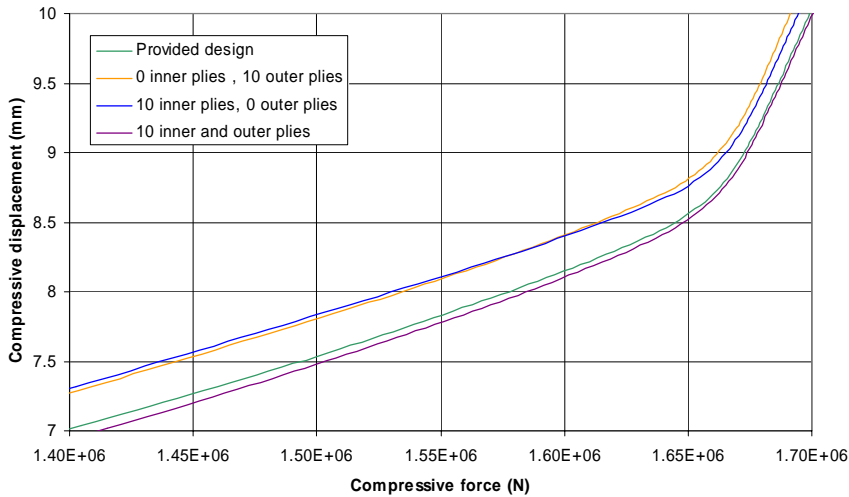
Figure 15. Non-linear design study results – with post-cure simulation.

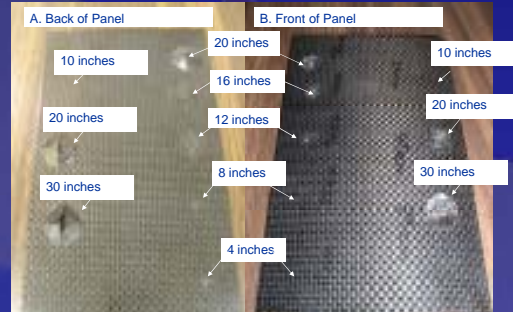
- Panel below (1/16" Epoxy / carbon fiber composite) shows damage incurred with drop of 2 lb, 1/4" diameter weight

- Delamination is observed when weight is dropped below 4 inch height, but not observed on the front surface until greater than 3X the energy

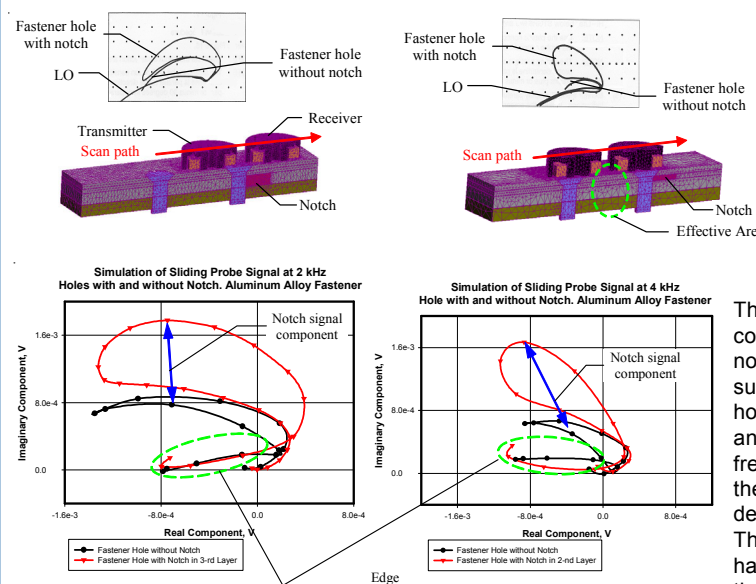
Simulated and actual fastener holes signals with and without notch in the third and second layer for sliding probe over multilayer structure.

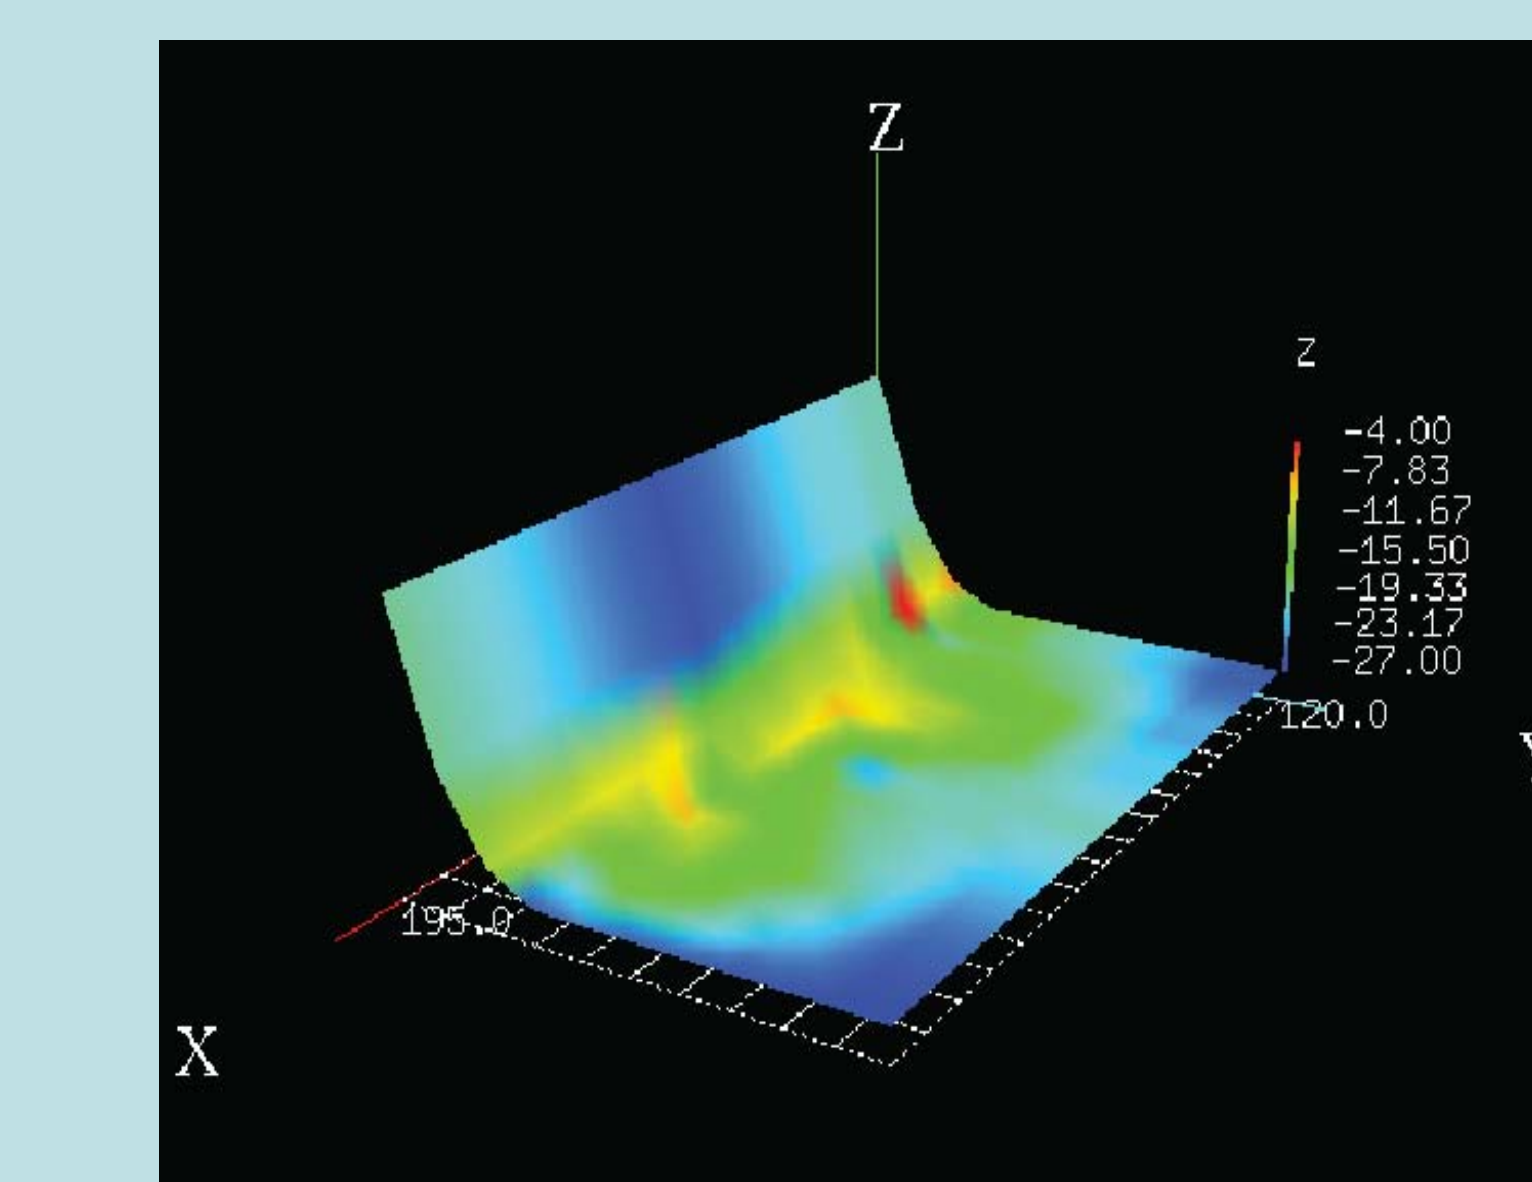
Residual stress map of a web to flange transition on a 7075 Al aircraft frame.
