C-5 Aging Fleet Integrity & Reliability Management (AFIRM)

***Rich DiSalle – LM Aero
Alex Gaskin – WR-ALC
December 1, 2005***

Converting A-10A DTA to AFGROW

December 1, 2005

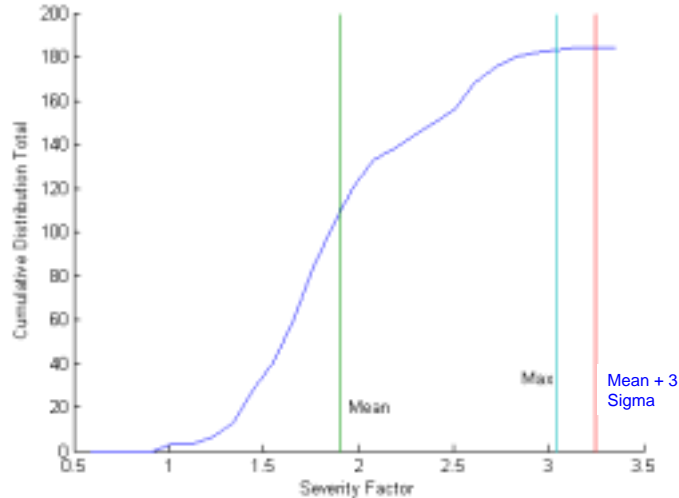
Severity factor distribution for all C-130E, Component Zone OW-1

The choice of a representative value facilitates scheduling inspection by MDS group.

It is customized for that MDS group because it only considers those tails within the group.

The SF values for a component zone and all the tails within an MDS group was examined. The max value was noted, as well as the mean plus three sigma value. The representative value was selected to be the smaller of the two.

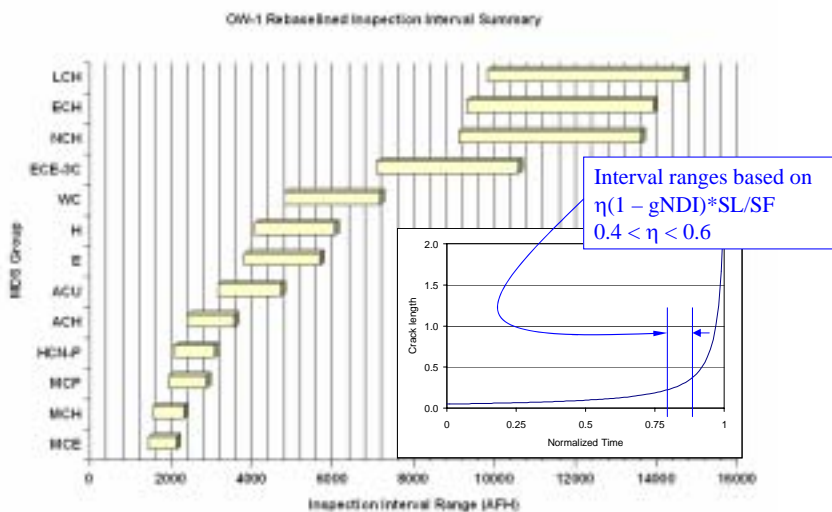
The inspection method and area being inspected establishes the crack probability of detection (POD), and a maximum crack size that can go undiscovered (aNDI)

The baseline DTA defines a time tNDI (in EBH) that corresponds to aNDI.

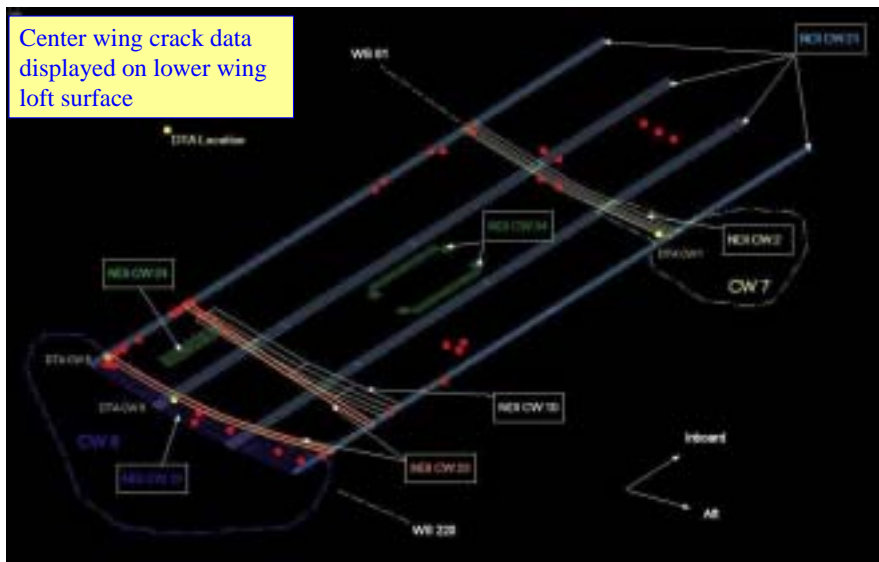
Center wing crack data
displayed on lower wing
loft surface

The crack data is available for analysis via numerical and graphical methods.

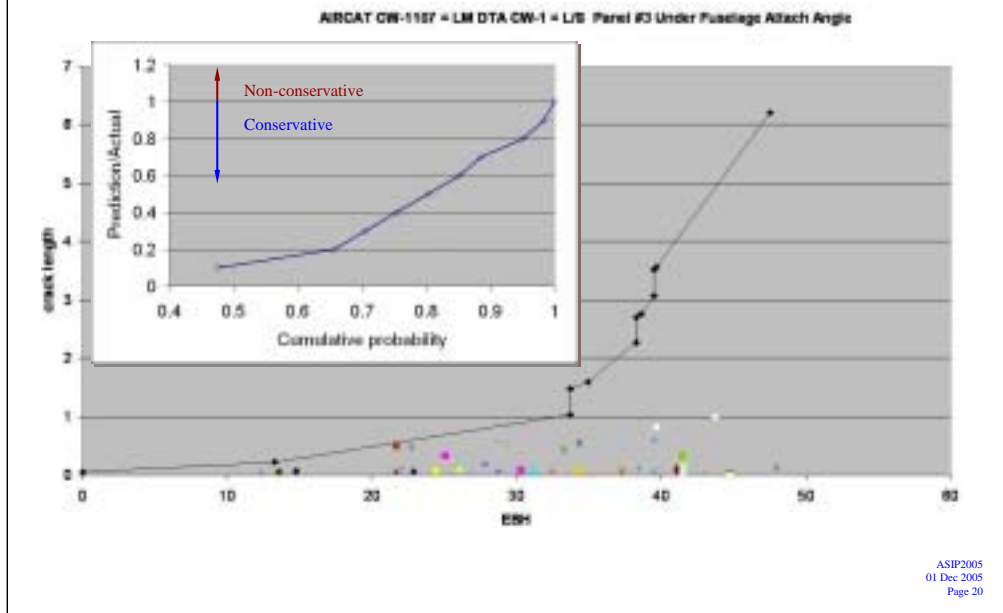
In this plot, information for cracks for a specific component zone have been extracted from the crack history database. Each crack may be plotted using its length and EBH at time of discovery as coordinates. The DTA crack growth curve used to track the component zone is then superimposed on the data.

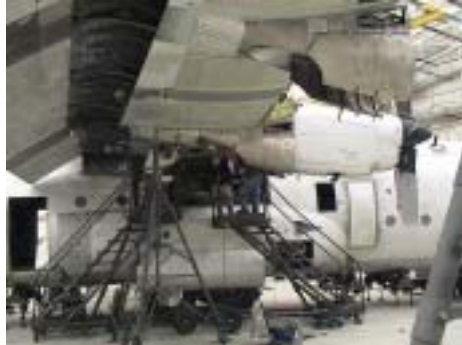
- **MOI Inspection of Lower Surface Panels**
 - Magneto-Optic-Imaging (MOI) system
 - HUD with signal output for image/video capture
 - Fast and effective inspection of major portion of lower surface
 - Allowed USAF to make quick assessment regarding restricted aircraft

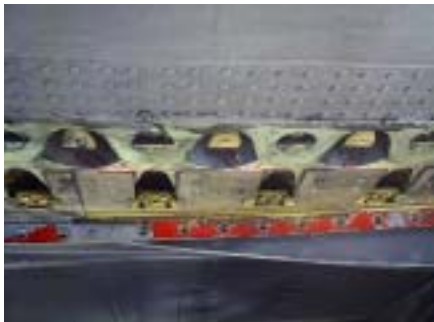
- Rainbow fittings, splice angles and attachments
 - Service cracking at multiple locations in wing joint area
 - Rainbow fittings and attachments transfer panel and stringer loads from OW to CW
 - Existing procedures updated

The next location deals with the rainbow fittings, splice angles and stringer attachments in the area of the wing joint.

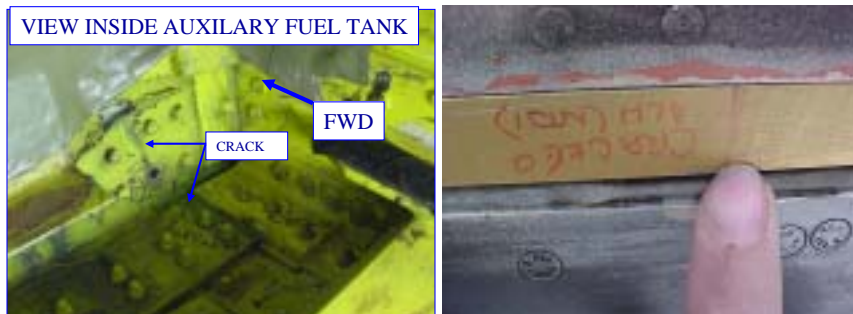
- Spar Caps
 - Service cracking at multiple locations on lower forward and aft caps
 - Extensive inspection area covered by several procedures
 - Existing inspections updated

The final location deals with the wing spar caps. The spar caps run the entire span of the wing box and provide connections for the upper and lower surfaces the front and rear beams of the center wing.
